Public Water System Annual Report

Southwest Regional Water Treatment Plant & Southwest Regional Water Co-op
2017

Date Prepared: 3/28/2018

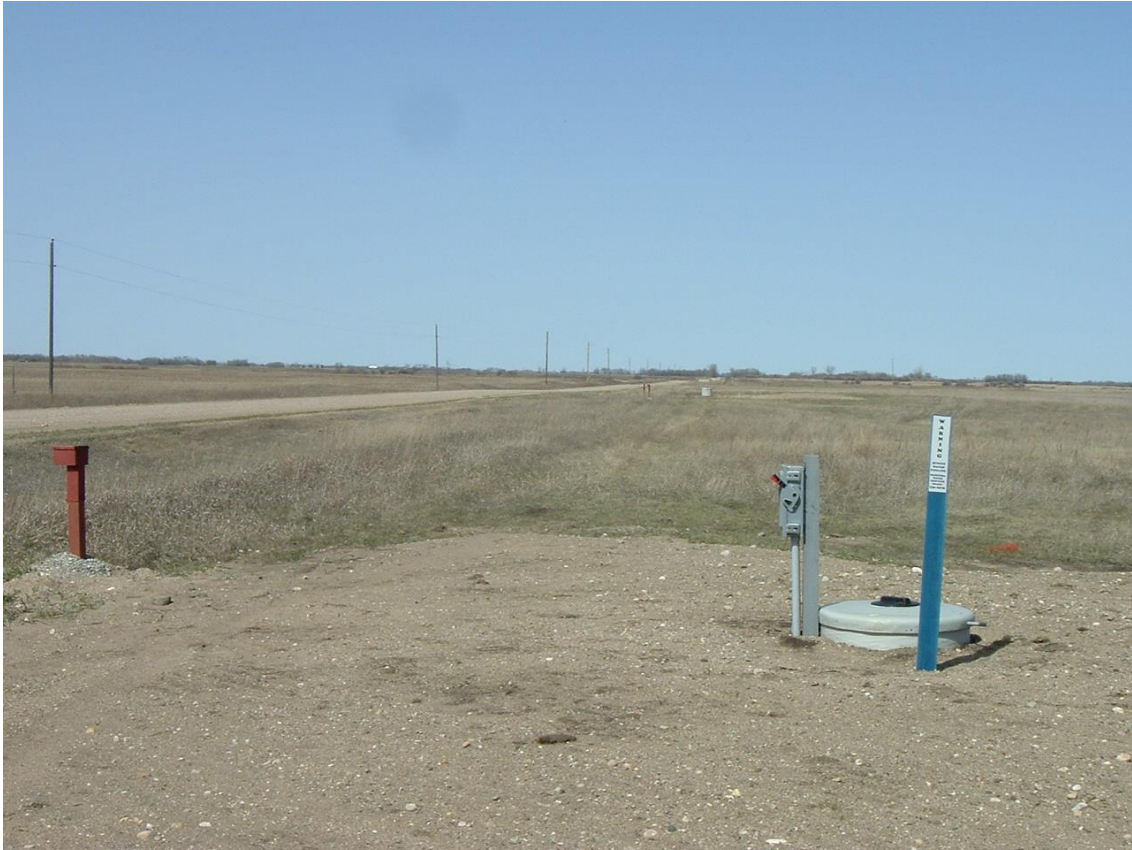
Recharge Wells

Since the middle basin could only be pumped intermittently, the north basin well was temporarily equipped with a pump, generator, and overland pipeline to speed up the water table recovery. Pumping from this basin occurred from September 3rd to September 21st until water levels significantly recovered and the north basin water table prevented further pumping. The water table in the north basin has since recovered. In 2012 the north basin was converted to a supplemental well to improve operating pressures and flows to the plant when it is in operation.

Currently, the middle basin well is intermittently pumped to the production well site in an attempt to maintain water levels until the new well field located on the SE24-5-27W can be put into operation. KGS Group determined that pumping from all three basins will not be sustainable to meet Melita demands and recommended developing the new well site. At this point the new east well field is still not in operation as all attempts to remove the iron bacteria from it have failed. More testing and engineering have come up with a plan to drill two new smaller diameter wells in the same location, that will meet future demands and allow the operation of both RO units at the same time. At the end of 2017 both new wells were drilled and they should be operational February 2018.

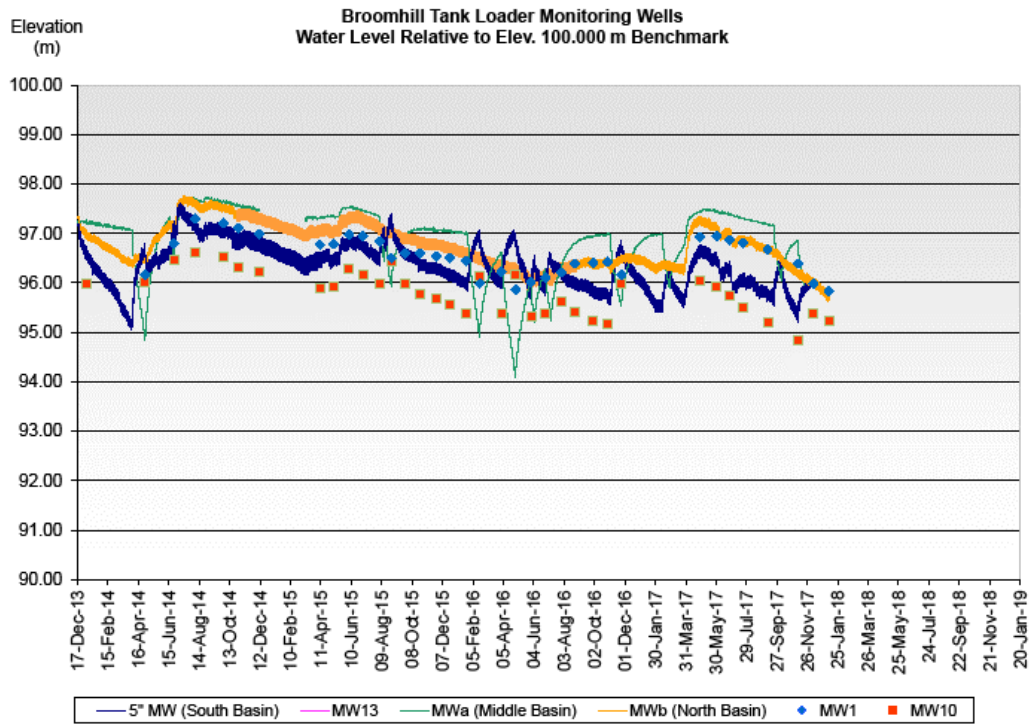
Groundwater monitoring commenced in July 2009. As many as four pressure transducers were initially set-up and currently three pressure transducers are continuous and manual readings. This graph uses a benchmark of 100.00 m in order to compare levels in each the three basins.

The locations of all monitoring wells are shown in the appendices. 5" MW represents the water table depth near the production well, while MWa and MWb represent the water table depth in the middle and north basins.

The updated graph on page 11 shows ground water levels at various points at and around the original wells.

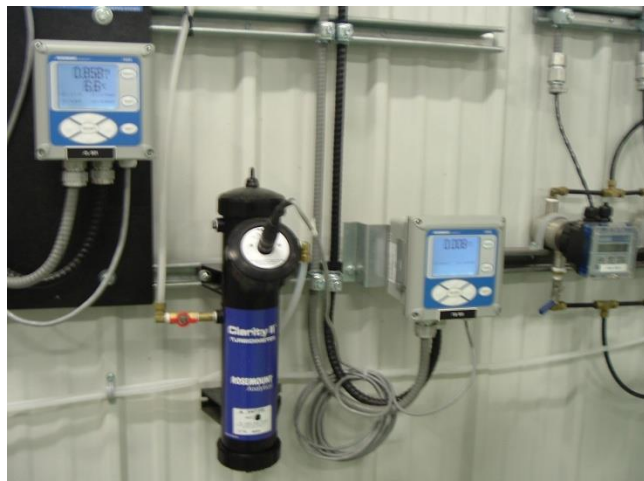
Online Monitoring Equipment

the chlorinators, as well there are two spare chlorinator pumps kept at the plant. Disinfection residuals are monitored continuously by an online monitor that monitors the water continuously as it leaves the WTP. We also monitor the residuals daily at the WTP and in the distribution system; these tests are performed at the WTP after the samples are collected. The results of all tests are recorded on our records at the WTP as well as Monthly Chlorination Report forms which are sent to the regional *Drinking Water Officer* at the end of each month, to check for standard compliance.
